STAFF REPORT: CITY OF TRINIDAD

APPLICATION NO: 2016-05

PROJECT LOCATION: 20 Scenic Drive

Culvert Failure Photos from January 21 City Staff Site Visit

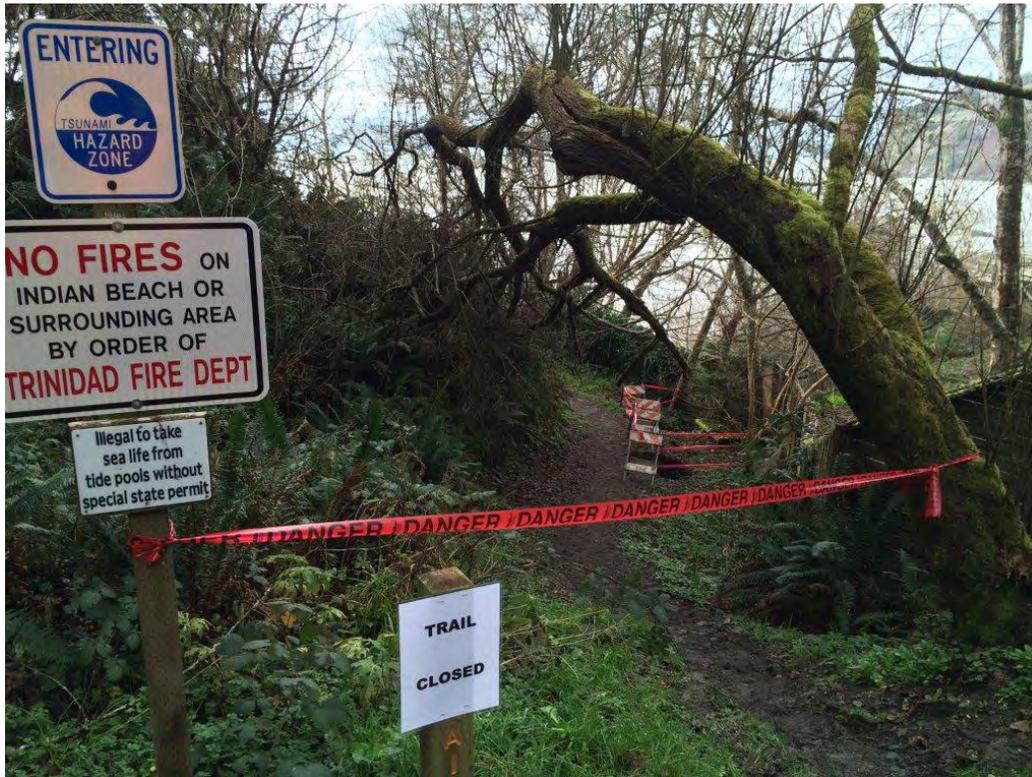
Figure 1:
View of the Parker Creek Trail closure due to a sinkhole along the culvert.

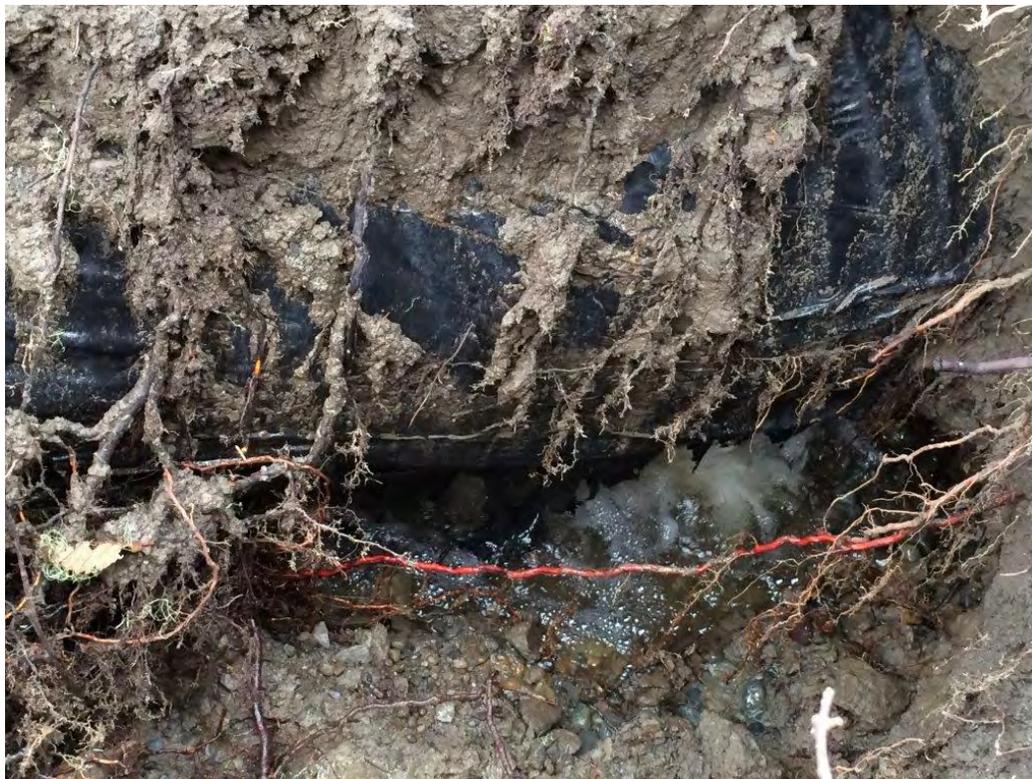
Figure 2:
Close up view of the sinkhole.

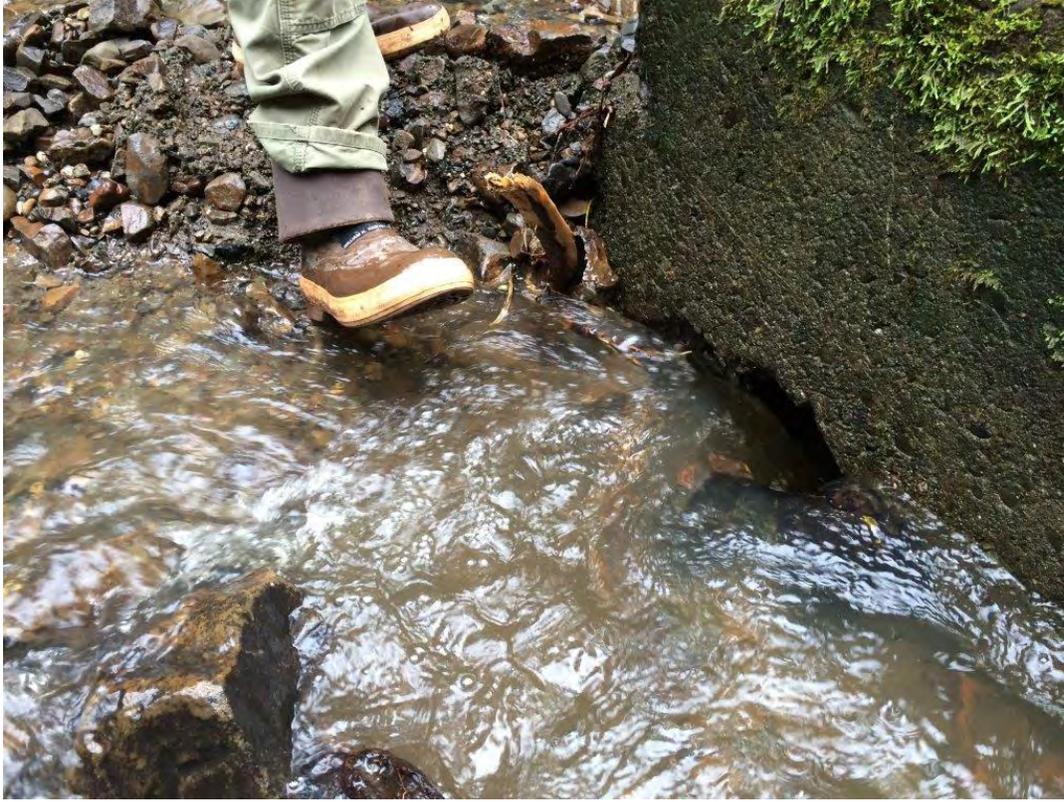
Figure 3:
Photo of
the
blocked
culvert
inlet.

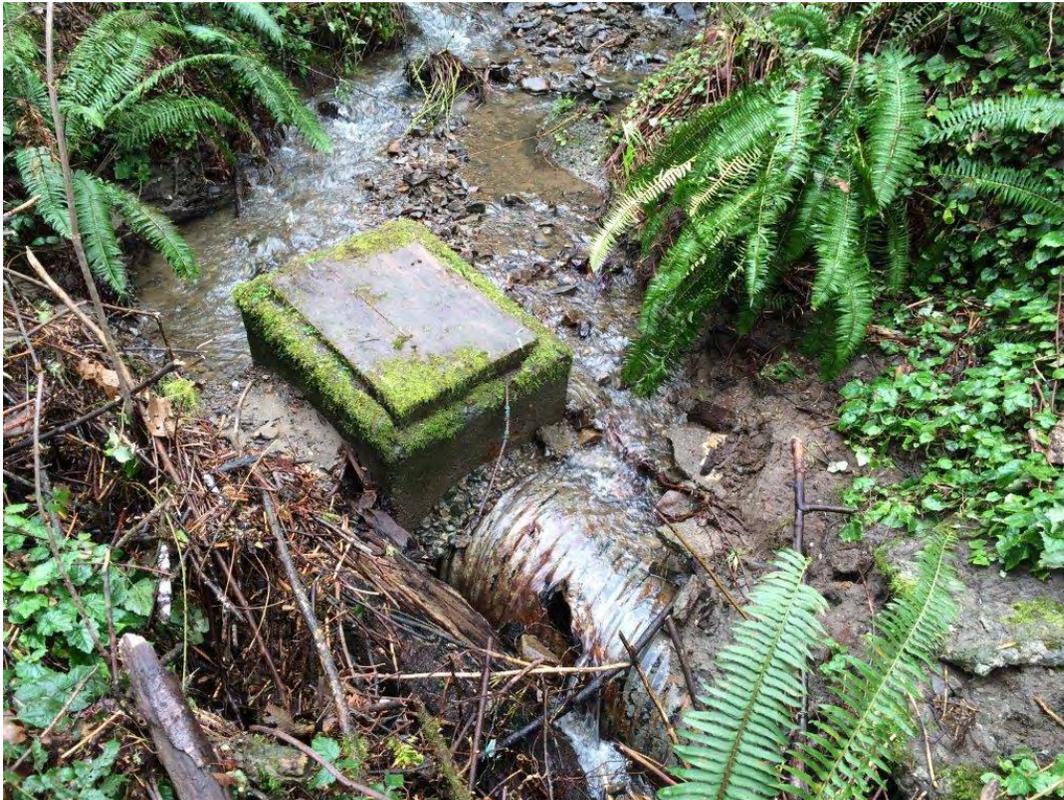
Figure 4:
Another
view of
the
culvert
inlet,
showing
the eroded
culvert
and the
flow
going
around
the culver.

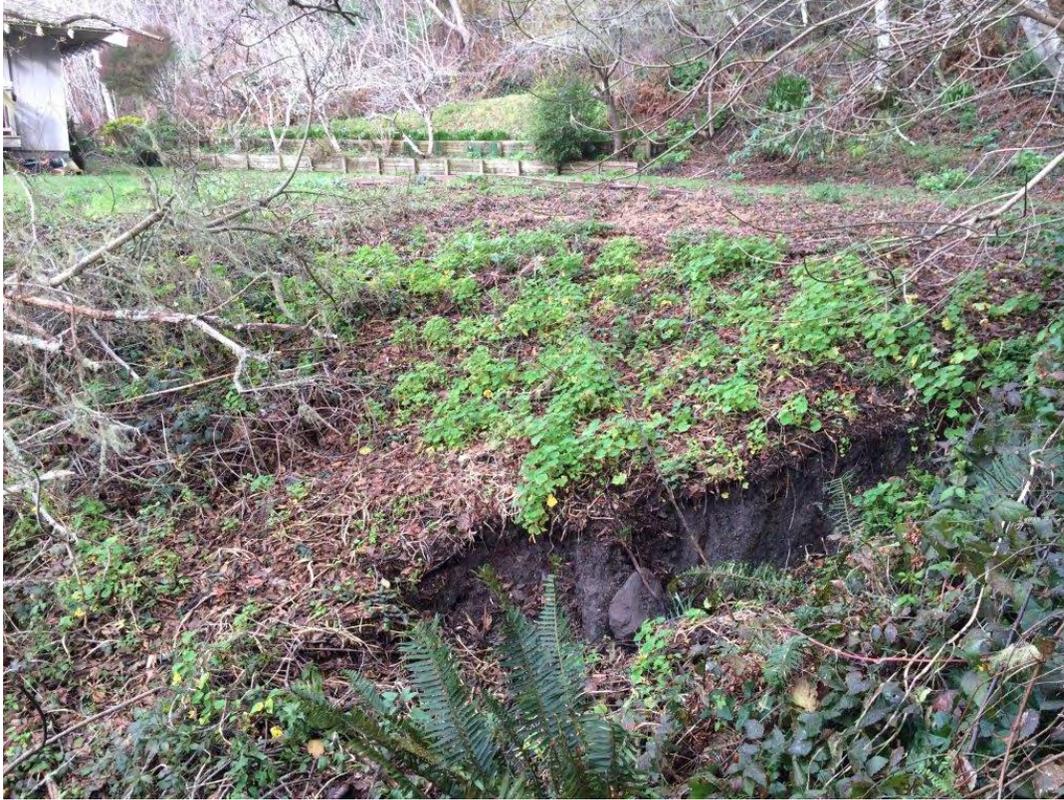
Figure 5:
Erosion
along the
culvert.

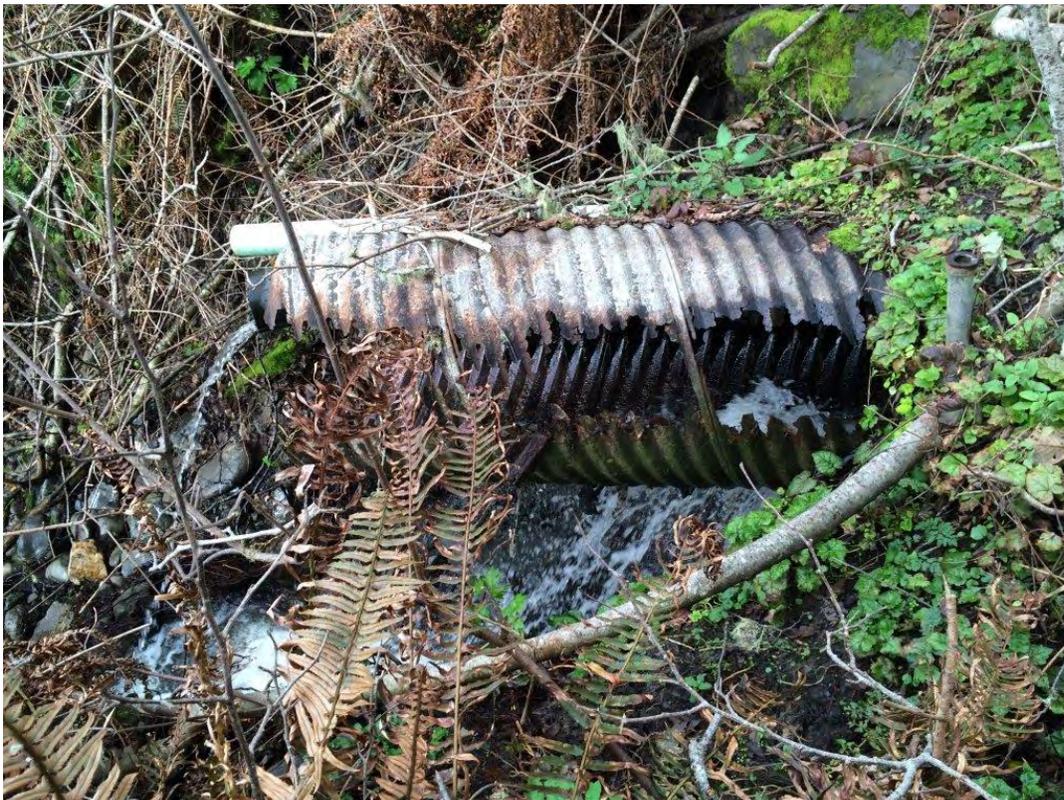
Figure 6:
Photo
showing
the eroded
culvert
outlet.
