Memorandum

To: Dan Berman, Trinidad City Manager Ref. No.: 01063-07-001

Subject: Storm Damage – Scenic Drive/Parker Creek

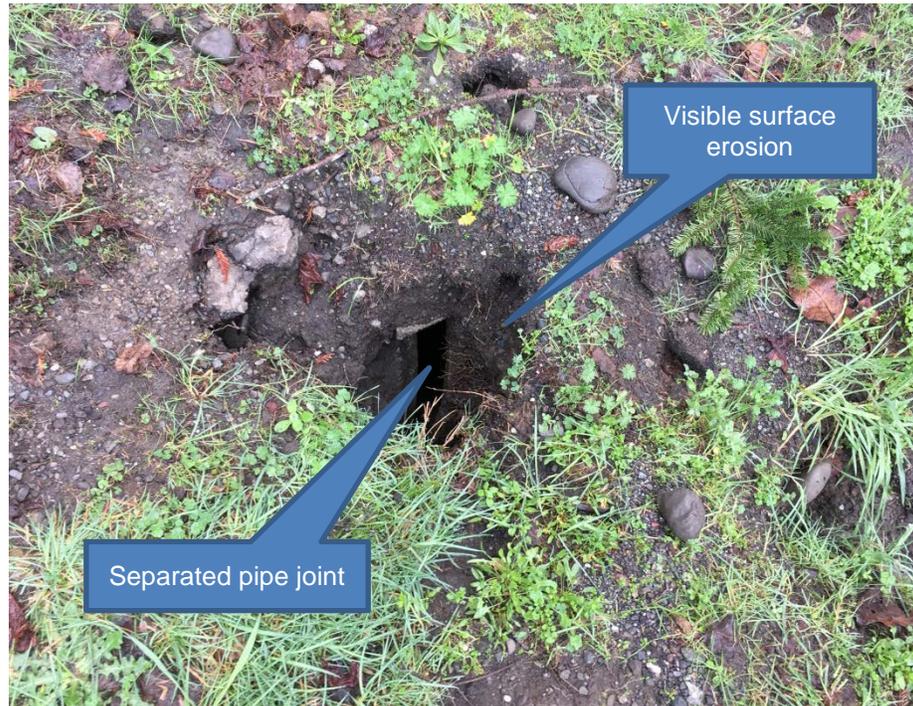
Separated storm drain pipe joint in Scenic Drive shoulder area with moderate surface erosion – The joint of two CMP culverts has failed/separated allowing surface runoff to enter the pipe. Active surface erosion visible in the area of the failed joint and it is likely to continue and get worse if no action is taken. See Photo 1.

Photo 1 – Separated joint in road shoulder with surface erosion visible.

- Install new concrete inlet (type G1 or similar) at the upstream joint separation (in road shoulder). Connect separated sections of pipe with chain or cable to prevent/limit further separation.

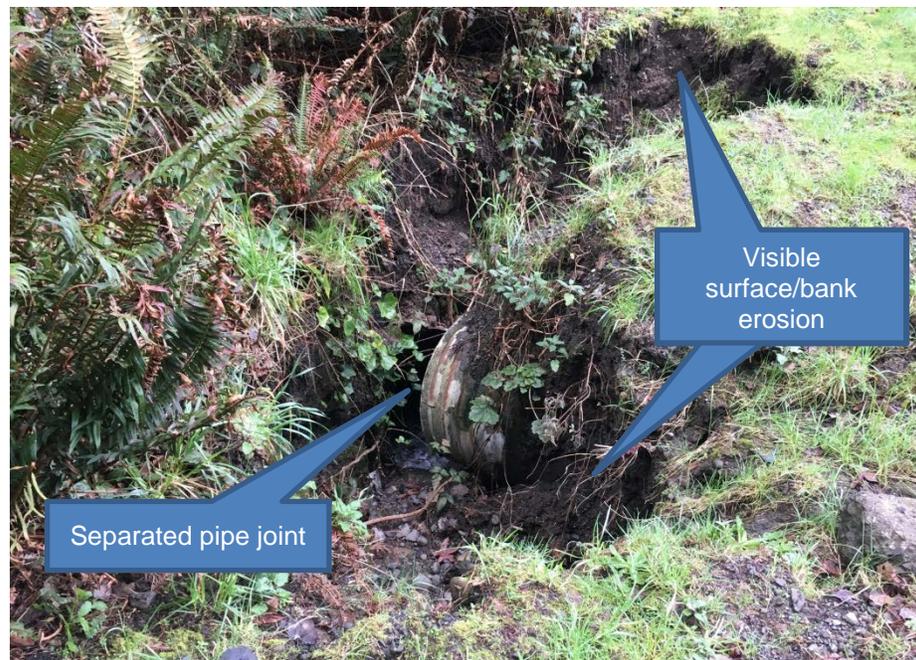
Separated pipe joint at top of down-drain to Parker Creek with significant erosion – The joint at CMP culvert and CMP down-drain has failed/separated allowing surface runoff to enter the pipe. Active surface erosion is visible in the area of the failed joint and it is likely to continue and get worse if no action is taken. See Photo 2.

Photo 2 – Separated joint at top of down-drain with visible surface erosion visible.

- Repair downstream joint separation (CMP or rubber collar). Connect separated sections of pipe with chain or cable to prevent/limit further separation.

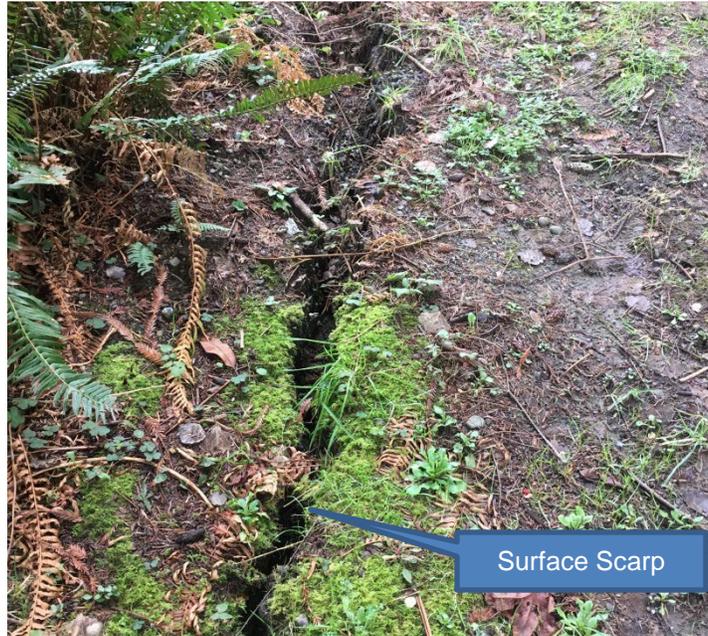
Ground surface scarp on west side of Scenic Drive – An approximately 30' long surface scarp was located just off the west shoulder edge of Scenic Drive. The scarp is likely evidence of active embankment slumping (the road embankment slumping towards Parker Creek). The slumping is likely to continue and get worse if no action is taken. See Photo 3.

Photo 3 – Visible scarp above Parker Creek embankment just off edge of road shoulder.

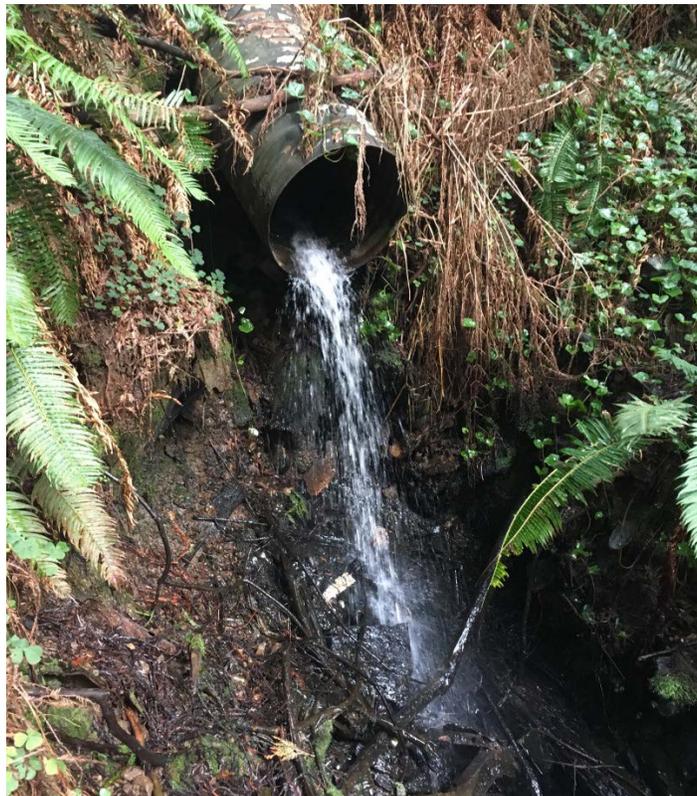
Perched down-drain outlet into Parker Creek – The outlet of the down-drain is perched 2-3' above the channel. The outlet pipe appeared to be intact with no visible holes in pipe and no visible signs of piping (drainage flowing on the outside of the pipe). The channel at the outlet is composed of bare ground, rocks, wood, logs, concrete rubble and other material. Only limit erosion was observed at outfall. See Photo 4.

Photo 4 – Perched down-drain outfall into Parker Creek.
