Reference: 017052

March 24, 2017

**Subject: Preliminary Assessment of Current Slope Stability Conditions,
Trinidad Memorial Lighthouse, Edwards Street, Trinidad**

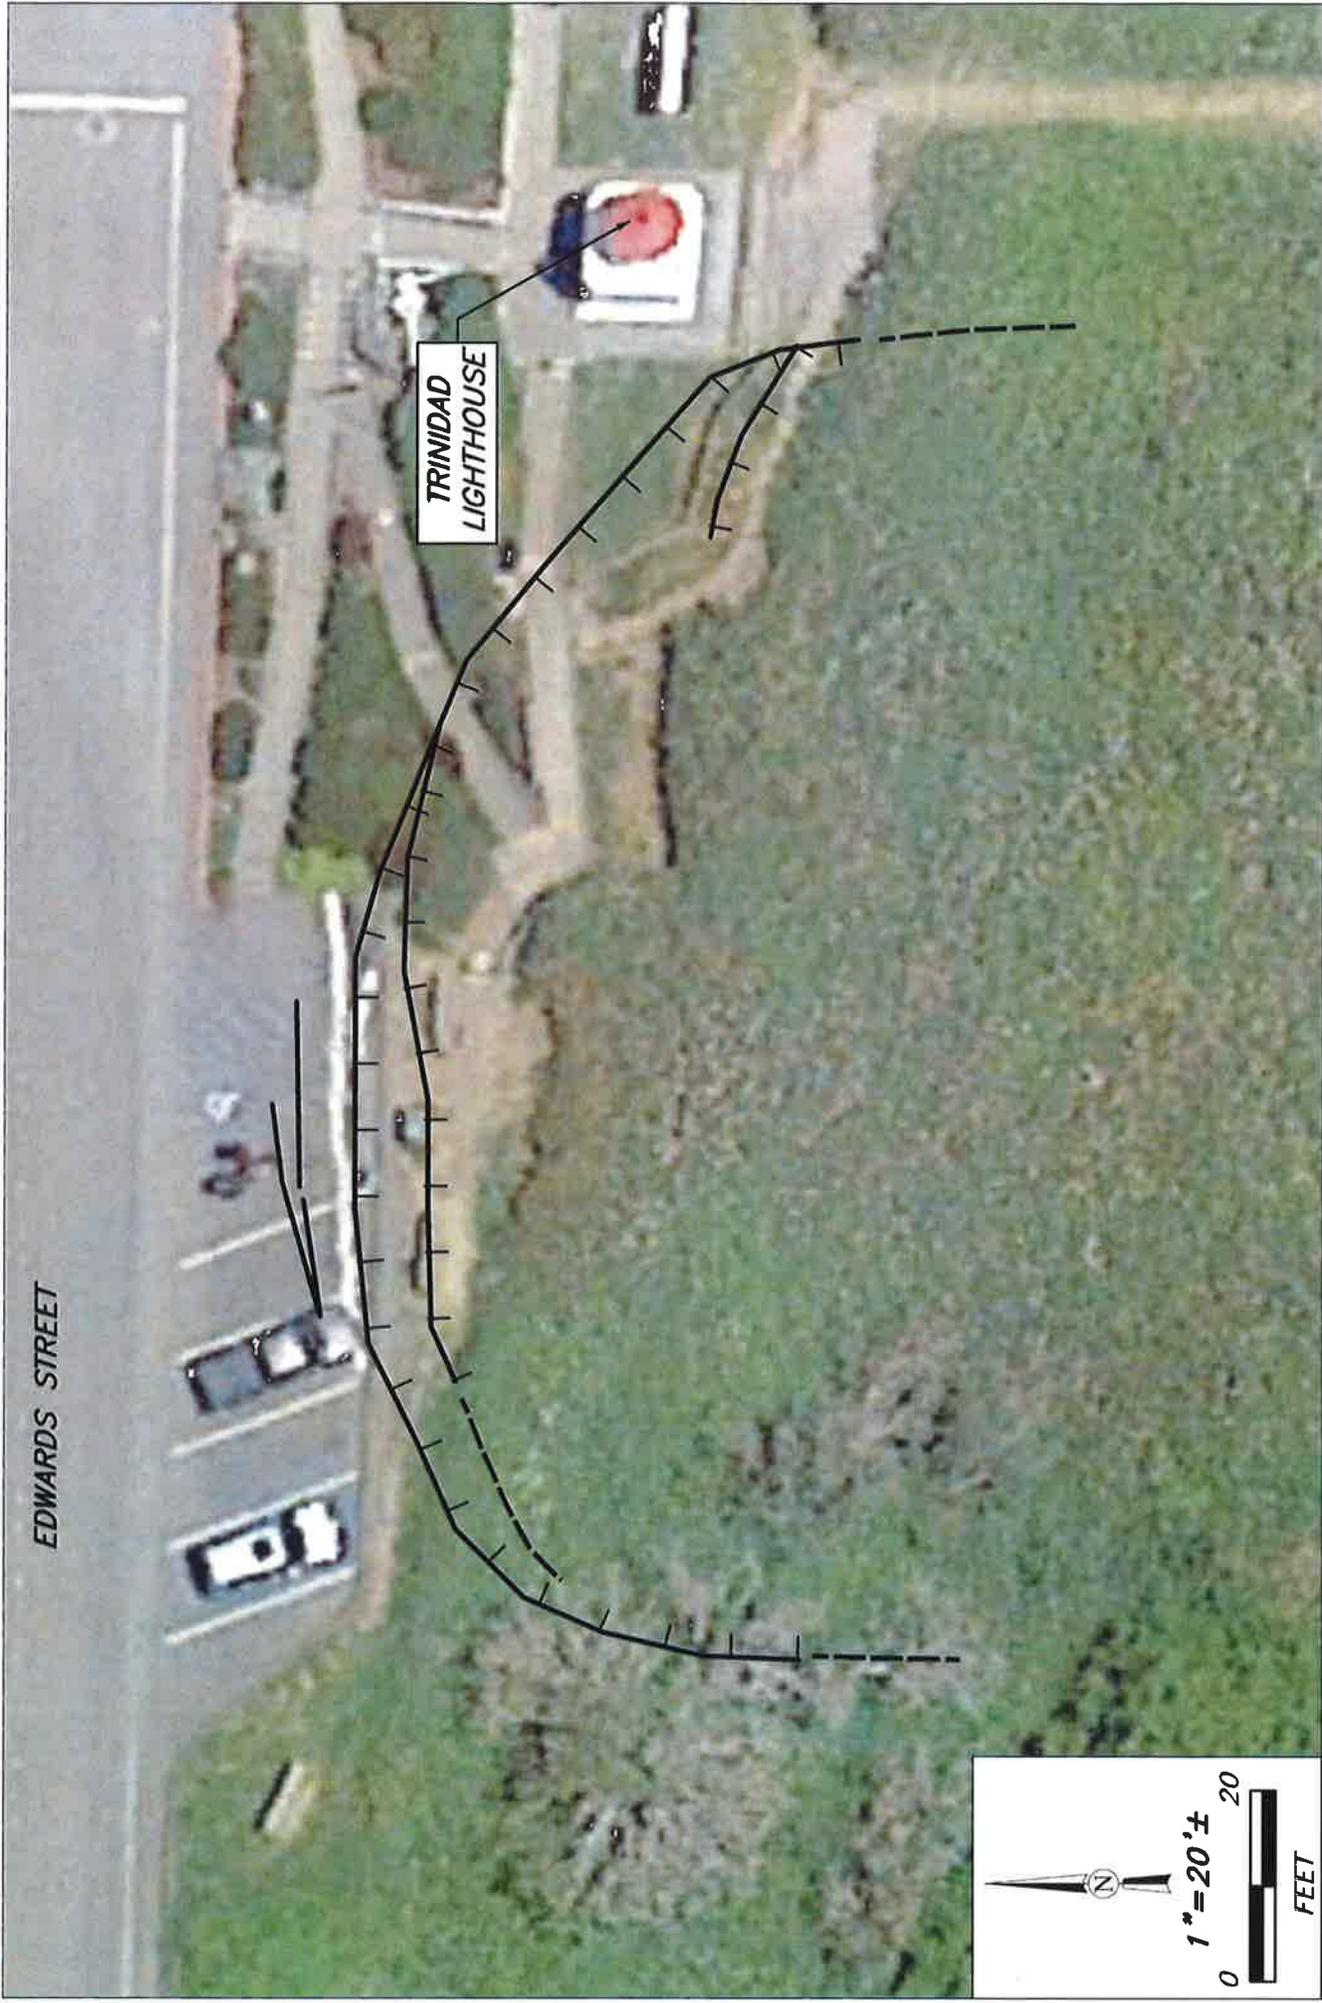
<p>IMAGE SOURCE: GOOGLE EARTH (5/26/2016)</p>	<p>SEW Consulting Engineers & Geologists, Inc.</p>	<p>City of Trinidad Lighthouse Landslide Assessment Trinidad, California</p>	<p>Site Map Showing Landslide Scarps SHN 017052</p>
			<p>Figure 1</p>

During our recent site visit we observed fresh vertical head and lateral scarps, and open fissures adjacent to the lighthouse, and extending approximately 100 feet westward through the paved parking area along Edwards Street (Figure 1). The fresh escarpment forms an arcuate feature that defines the head of an active earthflow-type landslide; the highest extent of which occurs in the parking area west of the lighthouse. The earthflow is occurring in low strength bedrock and overlying unconsolidated terrace materials on the bluff face (discussed below). Available geomorphic indicators suggest the slide is large and deep-seated, likely encompassing all or most of the bluff face below the recently active head scarp (that is, it likely extends to the beach). Landslides of this type are generally moisture-sensitive (they move under elevated pore water pressure conditions); therefore, the accelerated movement and expansion during the current rainy season can at least partially be attributed to the high levels of rainfall this year.

The recent episode of slide activity in this area initiated over two years ago, and appears to have substantially accelerated throughout the current winter season, especially over the past month. The height of the scarps and the amount of deformation recorded by the concrete walkways and ground surface displacement has significantly increased when compared to observations over a year ago and as recently as a few weeks ago. Tension cracks currently extend beneath the southwest corner of the concrete apron (sidewalk) located immediately adjacent to the lighthouse. Settlement of the grass-covered ground surface adjacent to the concrete apron is evident, and exceeds 6 inches. The main, active slide scarp has propagated to within about a foot of the southwest corner of the lighthouse's perimeter sidewalk.

The distribution of rock blocks in the bluff along Edwards Street can, in part, be estimated by the geomorphic expression of the bluff face. The Axel Lindgren trail that descends the bluff below the lighthouse follows a topographic ridgeline likely controlled by competent shallow bedrock. An obvious topographic bench midway down this ridge appears associated with a rock block that underlies this portion of the slope (Figure 2). In addition, an east-west oriented geophysical transect conducted along the southern edge of Edwards Street as part of the ASBS Stormwater Improvement Project Geotechnical Analysis (GHD, 2012) is useful in interpreting subsurface conditions near the site. The profile is particularly useful in interpreting the distribution of underlying bedrock. The profile indicates a relatively large bedrock block to be present in the subsurface to the east and north of the lighthouse. From the geophysical imaging it appears that the western edge of the block may underlie the lighthouse at a depth of 35 feet or less. In the area directly west of the lighthouse along Edwards Street, however, the geophysical profile appears to image the steep west-facing edge of the rock block. The location of the recently active earthflow appears to coincide with the western edge of the buried rock block at depth (that is, the slide is occurring in the materials just west of the stable rock block).

- Completely remove all concrete sidewalks that are currently in a state of disrepair;
- Remove all wooden fencing at the bluff edge;
- Remove the wooden benches at the top of the bluff within the affected areas;

- Construct or place a temporary barrier at the sidewalk around the west side of the lighthouse while directing access to the Axel Lindgren Memorial Trail around the east side of the lighthouse.
- Remove most of the paved parking area and curb while maintaining enough width for vehicles to park parallel to Edwards Street;
- Construct a new continuous asphalt or concrete curb on the seaward edge of the remaining parking area. The curb should be constructed in such a manner so as to direct surface runoff to flow back onto Edwards Street and be directed to the nearest downslope storm drain inlet. Grade the new parking area such that no ponding or overtopping of the curb can occur.
