STAFF REPORT: CITY OF TRINIDAD

APPLICATION NO: 2017-02

PROJECT LOCATION: Trinidad Memorial Lighthouse Overlook parking area and walkway, Edwards Street.

**Subject: Preliminary Assessment of Current Slope Stability Conditions,
Trinidad Memorial Lighthouse, Edwards Street, Trinidad**

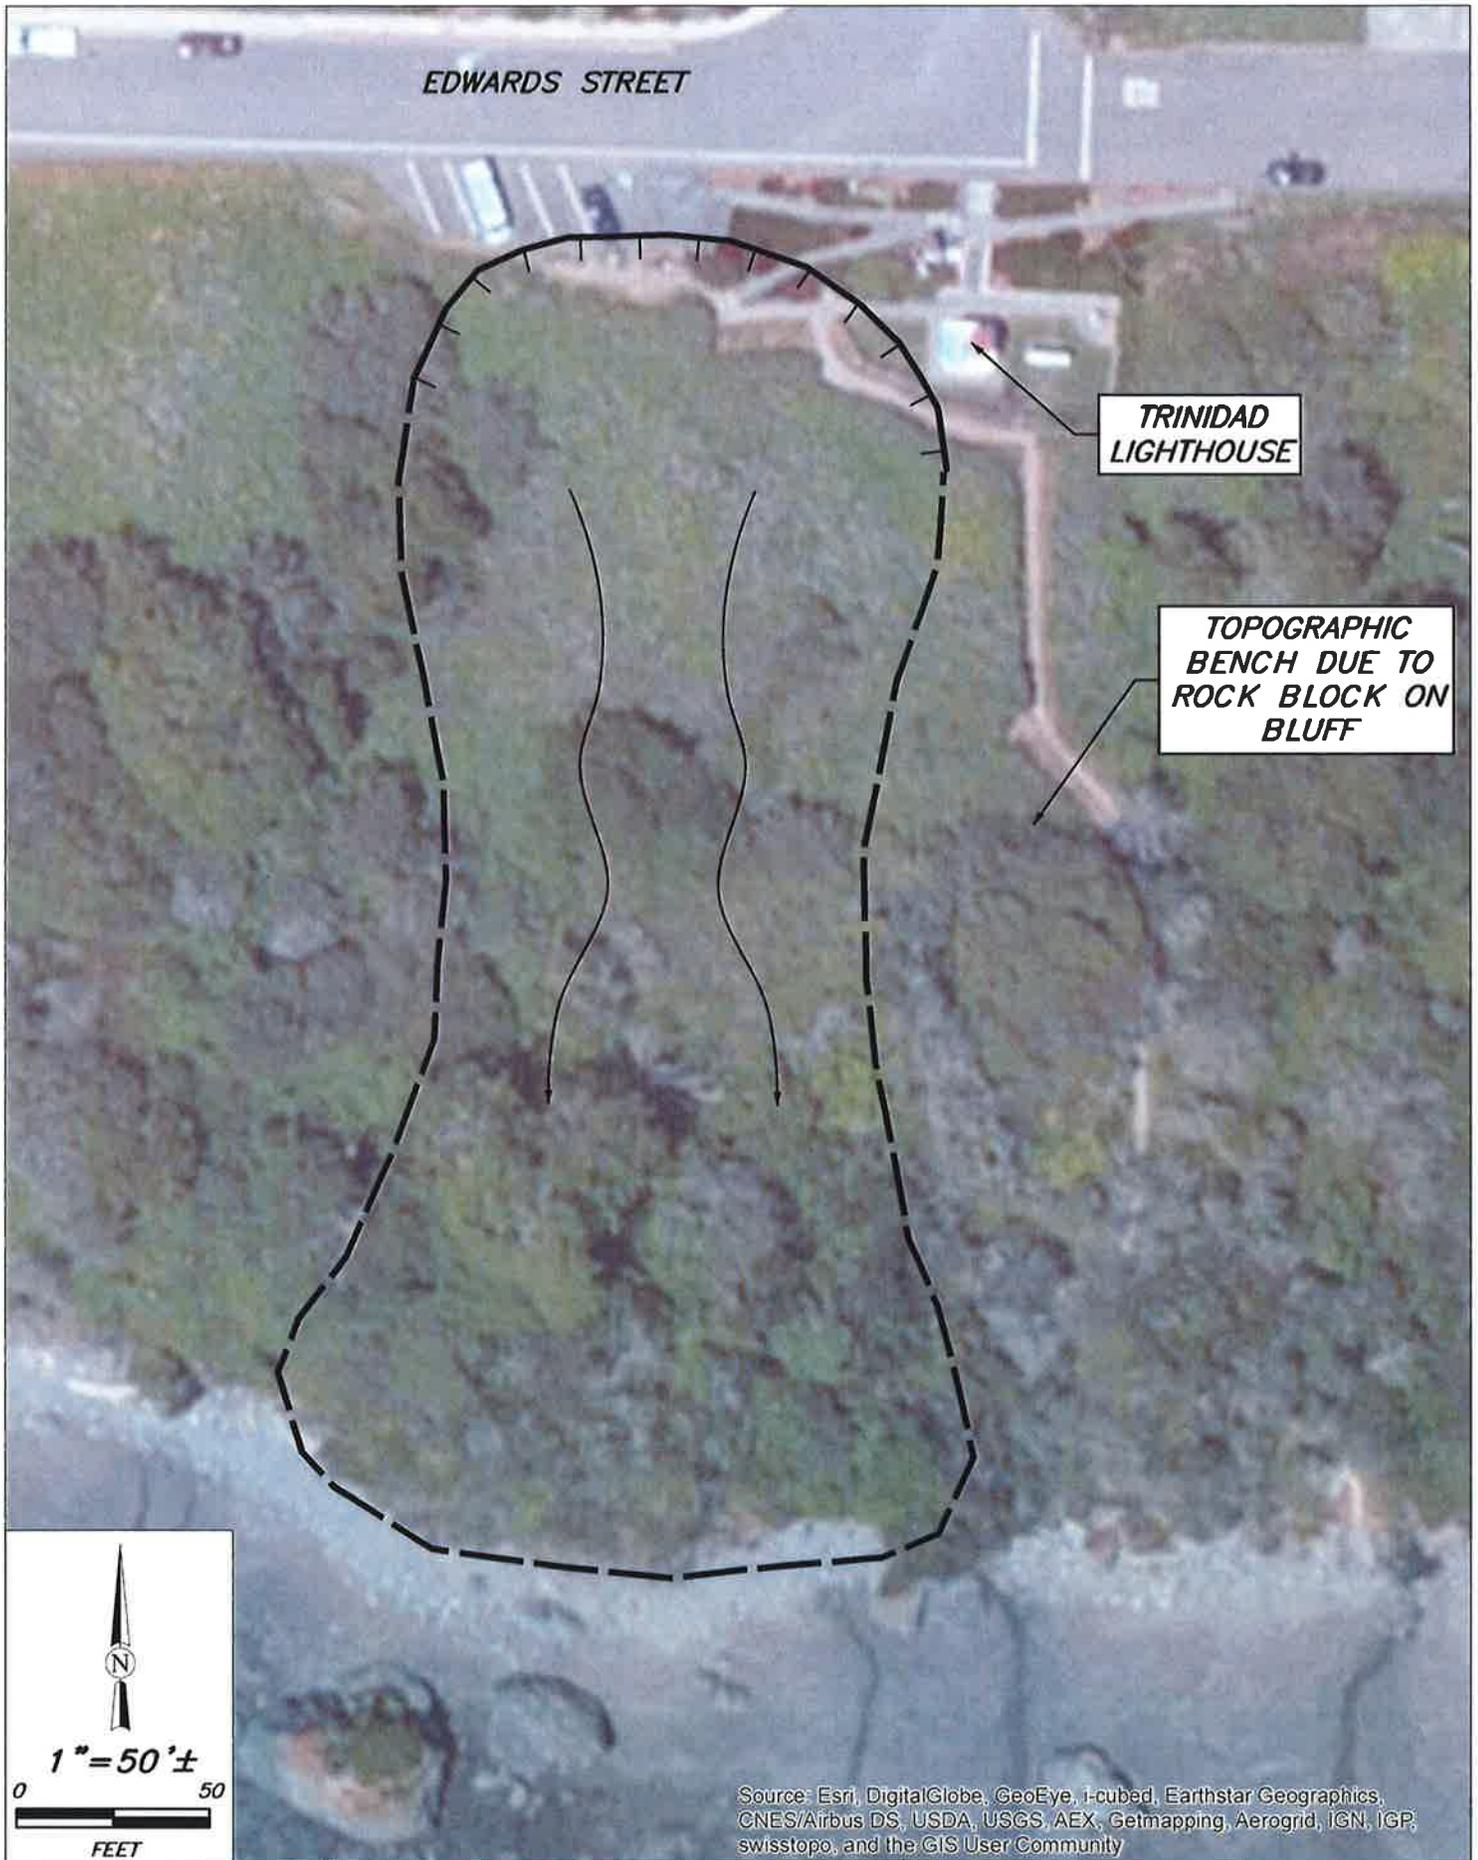
Figure 2

Slope movements now occurring near the top of the bluff are most likely occurring in response to deep-seated earthflow activity (previous or recent) within the underlying *mélange* matrix within the bluff. A review of time-series aerial photographs indicates the presence of an outwardly convex

bulge of *mélange* matrix at the back edge of the beach directly downslope of the observed landsliding that appears to have been mobilizing seaward for some time (Figure 2). The rate and magnitude of slope movements occurring at the top of the bluff has been observed to be greatest during the recent and previous wet seasons when pore water pressures within the clay-rich *mélange* matrix and overlying terrace sediments are highest and the water table is elevated. The large areal extent of the active earthflow underlying the zone of accelerated slope movement leads us to conclude that the recent wetter-than-average rainy seasons have exacerbated stability conditions within this previously dormant landslide. The addition of storm runoff into the subsurface, which has the effect of artificially elevating the ground water table, may also be contributing to the destabilization of the bluff edge. It should therefore be expected that episodic (or even chronic) slope movements will continue into the future at rates similar to, or even greater than, those of the recent winters (particularly if similar above-normal rainfall occurs). However, the timing and magnitude of future slope movements cannot be predicted at this time.

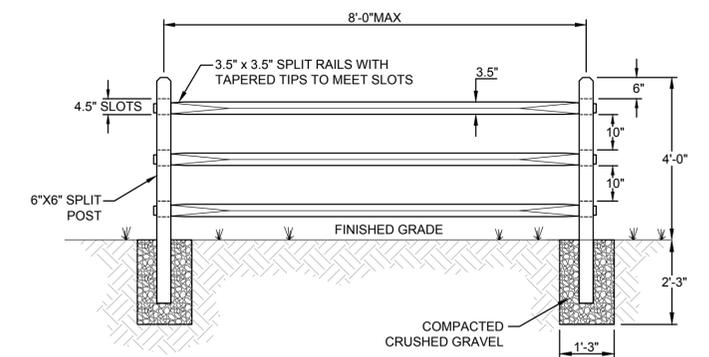
1
G-002 **TYPICAL SPLIT RAIL FENCE DETAIL**
SCALE: NTS

- NOTES:
1. ALL WOOD SHALL BE REDWOOD OR CEDAR.

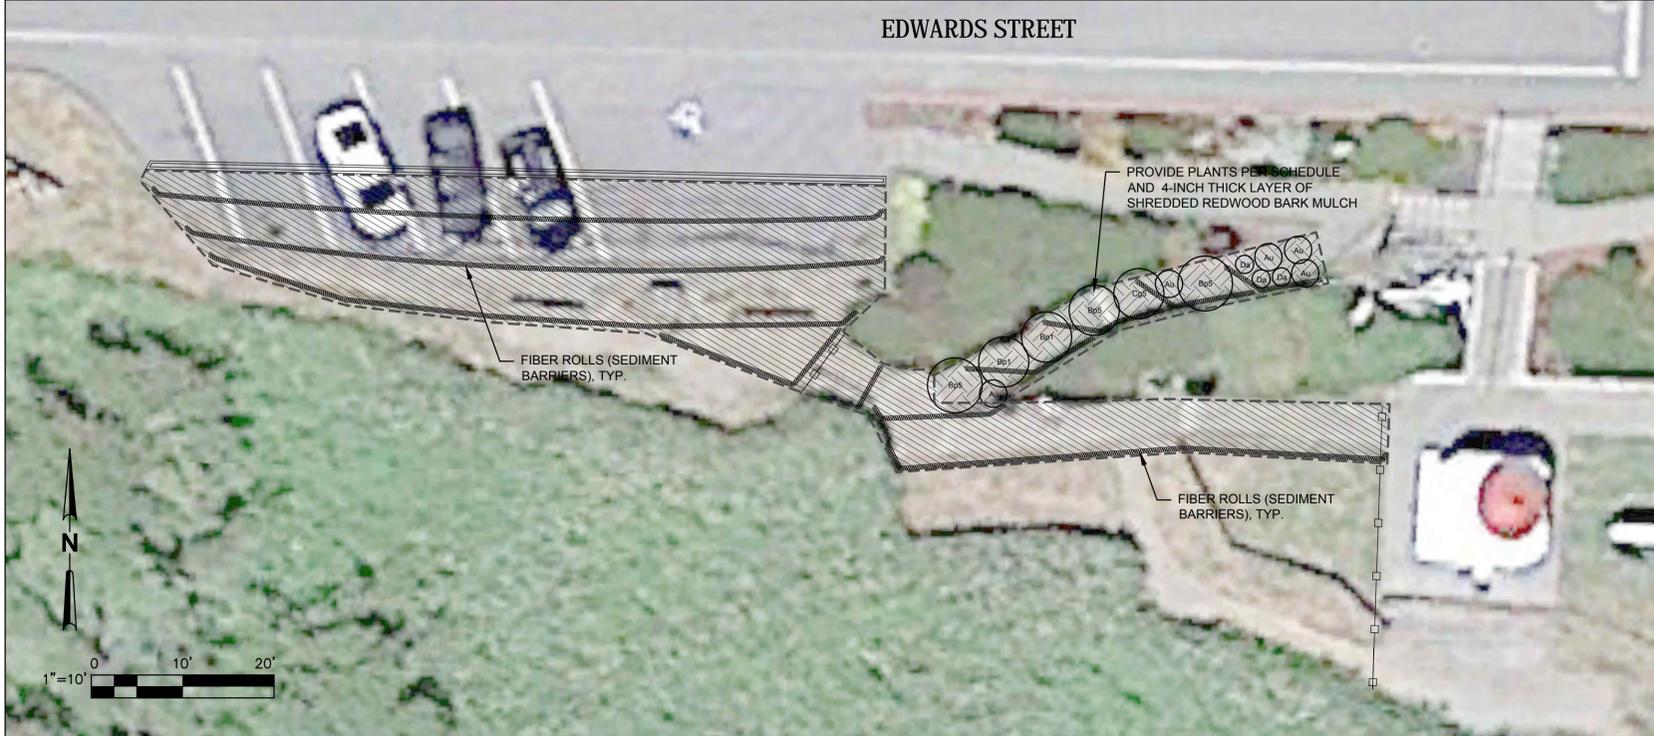
PLANTING & EROSION CONTROL PLAN

- ALL DISTURBED AREAS (INCLUDING HYDROSEEDED AND PLANTED AREAS) SHALL BE COVERED WITH EROSION CONTROL BLANKETS (TYPE A OR B PER CALTRANS STANDARD SPECIFICATIONS).

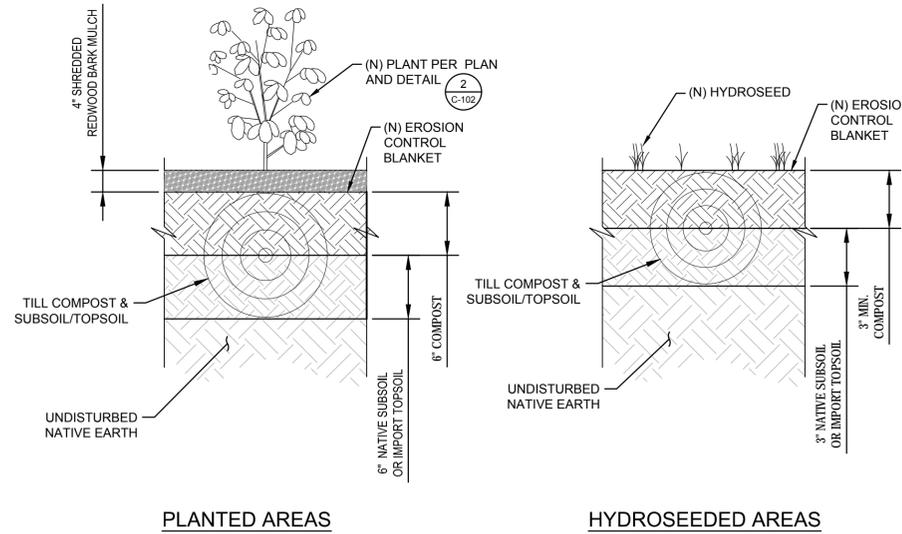
1 TYPICAL PLANTING SECTIONS
SCALE: NTS

- SEED MIX :
REGREEN HYBRID WHEATGRASS (*ELYMUS X TRITICUM*) 42%
BLUE WILD RYE (*ELYMUS GLAUCUS*) 17%
MEADOW BARLEY (*HORDEUM BRACHYANTHERUMIS*) 17%
HAIRGRASS (*DESCHAMPSIA CESPITOSA*) 8%
SMALL FESCUE (*FESTUCA MICROSTACHYS*) 8%
TOMCAT CLOVER (*TRIFOLIUM TRIDENTATUM*) 5%
CALIFORNIA BROME (*BROMUS CARINATUS*) 3%
