Memorandum

To: Dan Berman, Trinidad City Manager Ref. No.: 01063-07-001

Subject: Storm Damage – Scenic Drive/Parker Creek

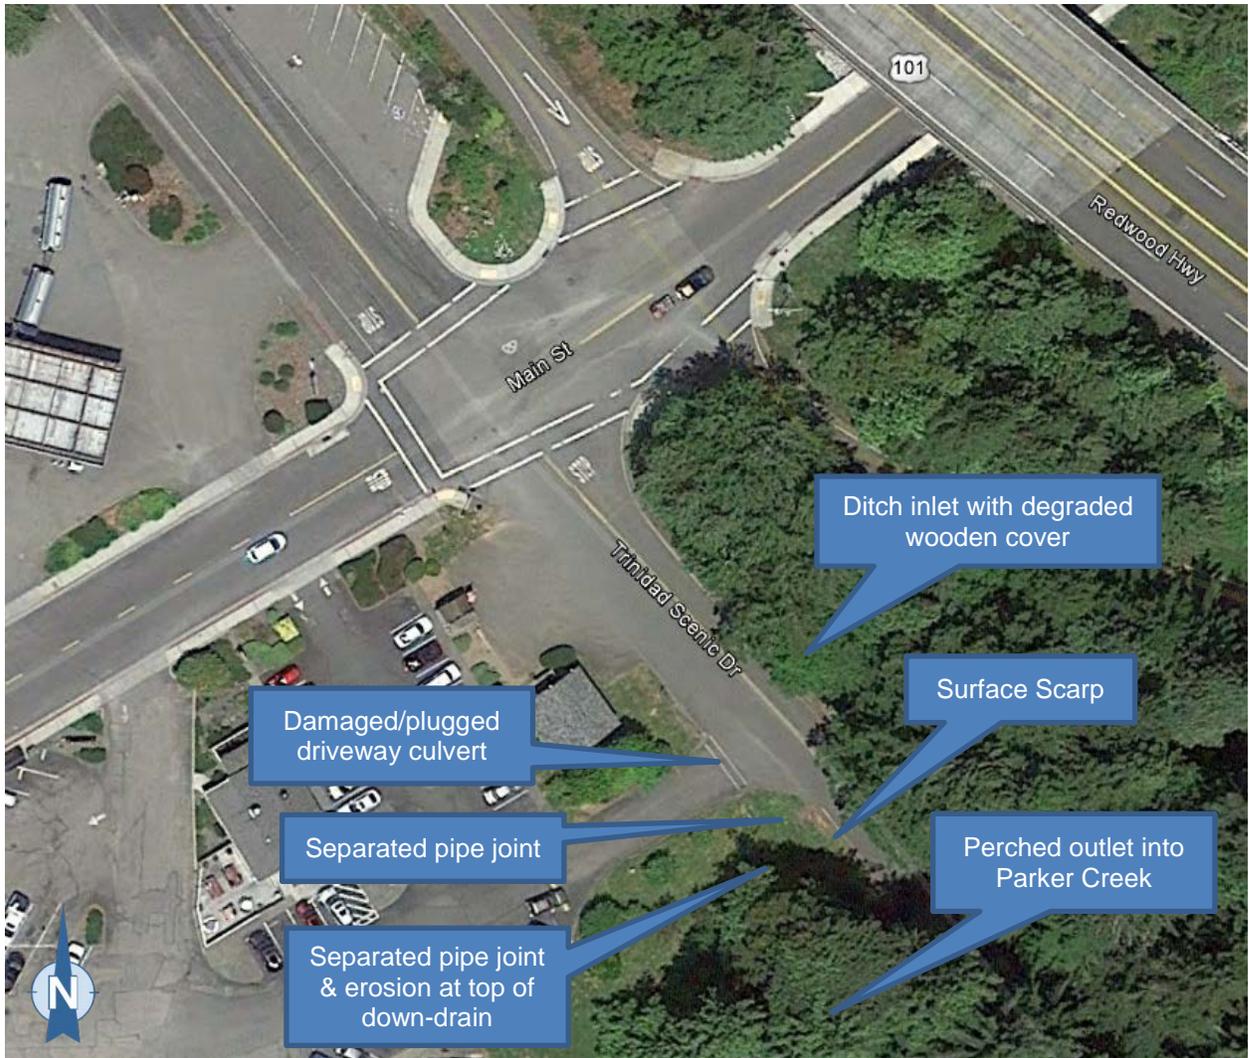
Figure 1 – Approximate locations of site observations

The following summarizes the primary site observations (see Figure 1 for approximate locations):
